**Technical Report 1681** September 1994

# VLF Cutler Hollow Core Cable Repair/Replacement

# NAVAL COMMAND, CONTROL AND OCEAN SURVEILLANCE CENTER RDT&E DIVISION San Diego, California 92152-5001

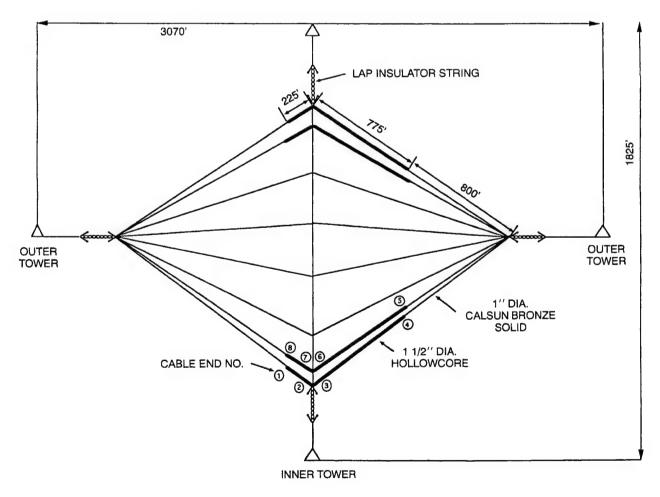
Figure 2. Cutler topload panel.

At present, external evidence of damage exists at the two locations shown below. The connection number refers to the numbered locations in figure 2.

Panel	Nearest	Connection	Replacement
Number	Tower	Number	Date
N-5	N6	3	1986
N-3	N2	5	1984

The external damage is similar to that previously observed (broken outer strands). At present, one outer strand is broken in one location, and two outer strands are broken at the other location. The breaks are within 2 inches of the jumper clamp near the swage end fitting.

NCEL recommended that clamps containing the copper jumper wire be replaced on the hollow core cable and a nearby clamp on the termination fitting in an attempt to reinforce the hollow core cable at the point where it enters the swage termination. However, all this did was to move the location of the problem. Note that the time from replacement to initial evidence of external failure was 6 to 8 years. The time until repair becomes absolutely necessary is not known because the internal condition of the cable is not known. To date, only visual inspections of the cable have been accomplished, and only minor exterior damage in two locations is visible. This, by itself, does not dictate the necessity for a replacement project. However, due to the hollow core construction, the cable can have internal breaks with no external evidence. The overall cable condition, including internal wires, cannot be determined visually. An x-ray program is needed to determine the extent of present damage, which can be used to estimate the breakage rate and remaining cable life.

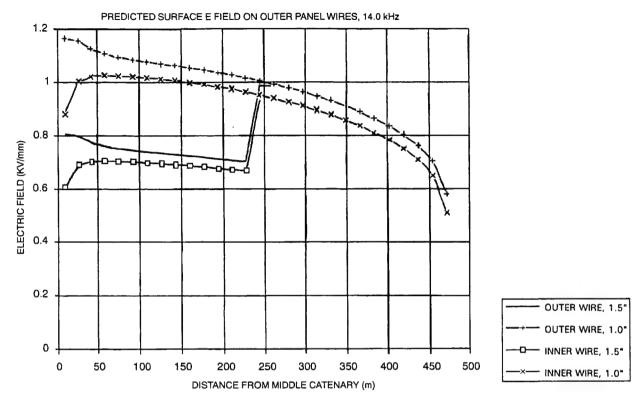
Figure 3. Cutler VLF tophat (14.0 kHz).

Using the above design limits and examining figure 3, it is clear that the Cutler design is marginal at 14.0 kHz from the point of view of corona formation. In fact, the 1.5-inch-diameter cable would need to be extended and the 1-inch-diameter cable shortened to reduce the maximum gradient on the 1-inch cable below the design limit of 0.95 kV/mm.

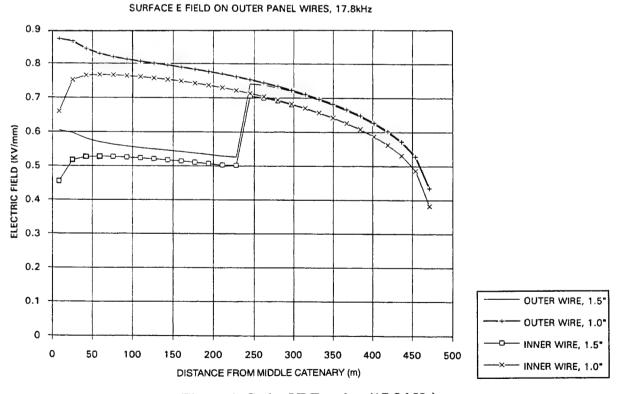
Figure 4. Cutler VLF tophat (17.8 kHz).

For operation on 17.8 kHz, the curve labeled "outer wire 1" in figure 4 gives the gradient that would exist if the 1.5-inch wire were replaced with a 1-inch-diameter wire. This curve indicates that this replacement would result in marginal operation at 17.8 kHz because the maximum gradient is slightly in excess of 0.95 kV/mm.

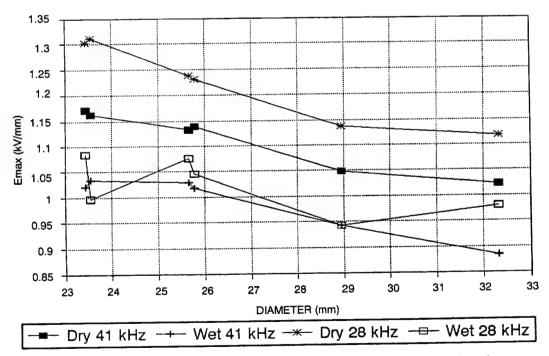
Figure 7. Corona extinction gradient versus diameter (uncorrected for air dens).

The gradient for corona extinction was measured on two frequencies at the Forestport High Voltage Test Facility for several wires having diameters in the vicinity of 1 inch. The results are shown in figure 7. Note that the gradient was calculated as if the wire were smooth.

By extrapolating the curve of figure 7 to a 1.5-inch- (38.1-mm) diameter wire, a design gradient of 0.8 kV/mm for wet conditions is adequate. Note that the frequency factor would make the extinction gradient a few percent higher than the results of figure 4 at 14.0 kHz (Watt & Hansen, 1992).

For the 1-inch- (25.4-mm) diameter wire, a reasonable wet design gradient from figure 7 would be 0.95 kV/mm at 28 kHz and a few percent more at 14.0 kHz.

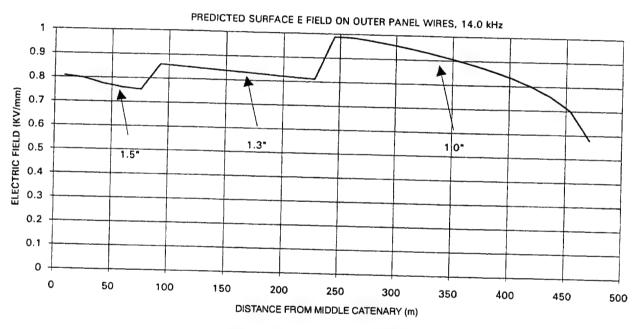
Figure 8. Cutler VLF tophat.

KW&H recommended two 1.3-inch-diameter cables, which are shown in tables I and 2. One cable is made up entirely of a copper alloy with 8.5% conductivity of copper. The other is a special cable using a higher conductivity copper alloy Cu 851 for the exterior and a stainless steel core. A 1.3-inch-diameter cable could be used without reducing operational capability by retaining a length of the 1.5-inch-diameter hollow core cable in the region where the gradient is highest. The approach is to retain 250 ft of the hollow core in the outer half panel at the catenary end. The remaining 550-ft section would be replaced with the new 1.3-inch-diameter cable. A plot of the estimated gradient at 14.0 kHz is included in figure 8, which shows that the maximum gradients for this option are within the design limits for corona formation.

This short length of hollow core presumably would not have the breakage problem. Even if it did, enough spare hollow core remains to replace it two more times. The remaining 550 ft would be made up of the new special stainless-steel core 1.3-inch-diameter cable. This cable adds 0.684 lbs/ft, or about 1505 lbs per panel, and requires removal of only two insulators per panel. This option will be less expensive than option I because the cable diameter and length required are smaller; thus, less material is required.

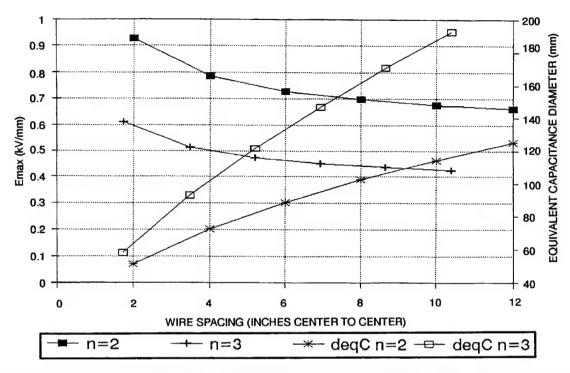
Figure 9. Cutler topload estimated cage gradient 1.01-inch-diameter wires near the catenary.

In order to control the gradient, this cable would have to be paralleled with a 1-inch copper jumper held in place by Burndy clamps. In effect, this forms a 2-wire cage. Appendix D gives the details of the calculation of the maximum gradient that would occur on a small section of the 2-wire and 3-wire cage in the Cutler topload by using the methods of Hansen (1992). The gradient versus wire spacing at 14 kHz for 2- and 3-wire cages made from 1.01-inch wire and located near the catenary are given in figure 9. Note that the 2-wire cage gradient is slightly over 0.9 kV/mm, which would be acceptable for a 1-inch-diameter wire from figure 5. However, the equivalent diameter to use for the corona onset of a cage is not known exactly. At 60 Hz, some data indicate the cage equivalent diameter for capacitance (see appendix D for definition) is a good approximation to the equivalent diameter for corona onset (see figure 6 of Miller, 1956). If this is so, then the design gradient for the cage should be 0.8 kV/mm. In order to get gradients below this value, the 2-wire cage would need to have the wires spaced apart with a center-tocenter wire separation of 4 inches. From figure 9, it is shown that a 3-wire cage would be acceptable with wire separation of only 1 inch. These are the recommended wire separations for these two cages. It would be useful to investigate this phenomena to determine a better value for the equivalent radius for corona onset. The 4-inch wire separation for the 2-wire cage means that the special clamps will be required, giving the wires the required 4-inch center-to-center separation. For the 3-wire cage, the standard clamps give adequate spacing.

This cage section will not deice, but since it is short and located at the support catenary, this is acceptable. The major cost of this option involves installation, which could be done by Cutler personnel. This fix would extend the life of the hollow core for about 10 years and could be repeated once more for another 10 years. It is the least expensive and could easily be available to start installation by next summer. The 2-wire version of this option is the recommended short-term fix for any cables that the x-ray program indicates will need immediate repair.

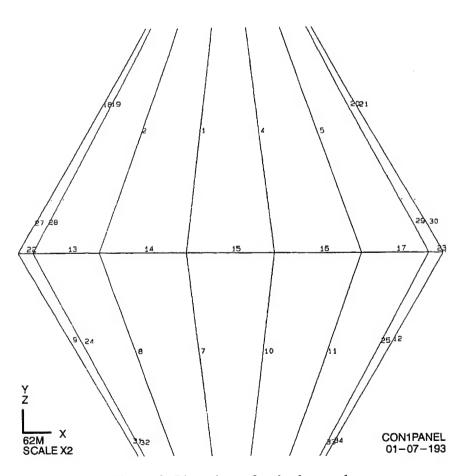
Figure 2. Plan view of a single panel.

However, this required 2997 unknowns and took several hours to run. We thought it impractical to increase the resolution beyond this point. Table 1 summarizes some of the specific dimensions used for each configuration. The wire numbers correspond to those in Figures 2 and 3. The 1.5-inch wires in configuration 1 that we have plotted data for are 9, 24, 27, and 28. The 1.0-inch wires are 18, 19, 31, and 32. The wire numbers for configuration 2 are 9, 18, 19, and 24.

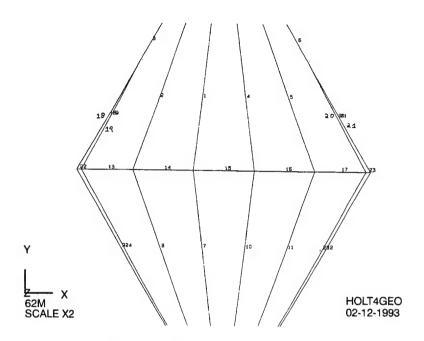
Figure 4. Plan view of a single panel, configuration 3.

As with configuration 2, the small distance between the two extremely long wires forces us to model them as a single wire near the vertex of each panel. However, we have to increase the length of the single wire from approximately 33 meters (108 ft) to 273 meters (895 ft). This is a significant change, but it is necessary to allow NEC-4 to recognize the wires as separate. The segmentation is similar to configuration 2. Charge samples occur at approximately 17 meters (56 ft) intervals. This results in 2829 unknowns. Table 3 summarizes some of the dimensions for this model. The wire numbers correspond to those in figure 4.
